# Manhole Inspection Summary

Manhole # S53I\_\_002MH

Insp Date: **5/28/08 8:38 AM**

**Location** Address: **3113 eastern ave**

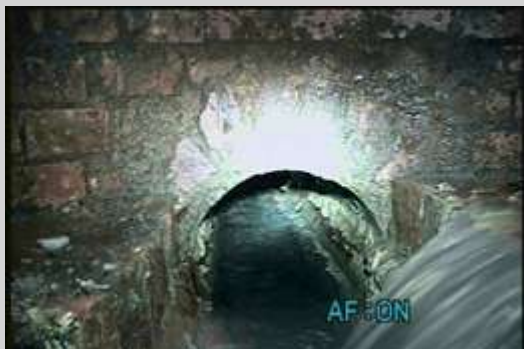
3 O'Clock Inflow

8 in. Circular Gravity Sewer  
Pipe In @ 3 O'Clock

Pipe Material: **Clay** ☐ Pipe Lined

Infiltration: **None** Pipe Seal Cond: **Unknown**
